Revealing Pathway of Leakage Under a Small Pond, Using Dipole-Dipole Resistivity and Shallow Seismic Reflection; A Case History at Tum Huai Luk Project, Chiang Mai, Thailand.

N. Poomvises, N. Sangthong and A. Kongsuk

Geophysics group, Geology Section, Office of Topographical and Geotechnical Survey, Royal Irrigation Department, Bangkok, Thailand

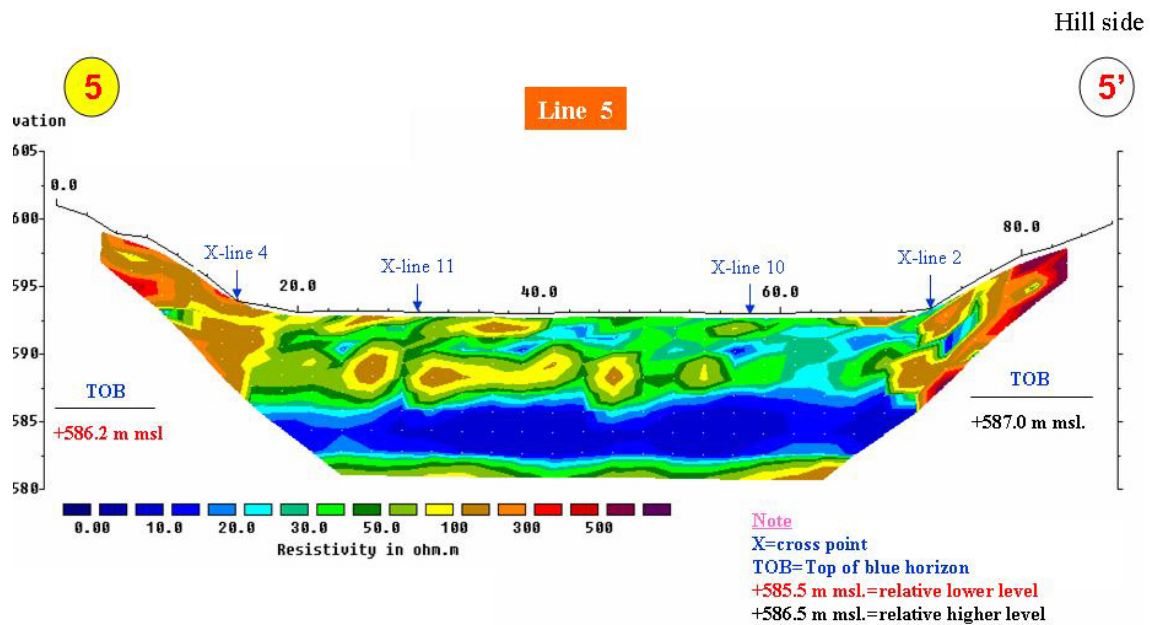
The resistivity investigation consisted of 11 profile lines (Figure 2). This survey used a SYSCAL R1 switch, a French IRIS instrument, 24 nodes, 2.5-meter electrode spacing, and had a 20-meter penetration depth. Survey lines 1, 2, 3, and 4 were designed to check the lower edge of the pond on the floor level. Lines 1, 5, 6, 7, 8, and 9 were perpendicular to the axis of the buffer pond. Lines 10 and 11 were parallel to the pond's axis. The resistivity raw data were good and were modeled using RES2DINV processing software of M.H. Loake, GEOELECTRIC, Malaysia. Modeling results showed three different layers on most of the processed lines (Figure 3).

Figure 3. Typical three-layer model by inversion modeling in this study

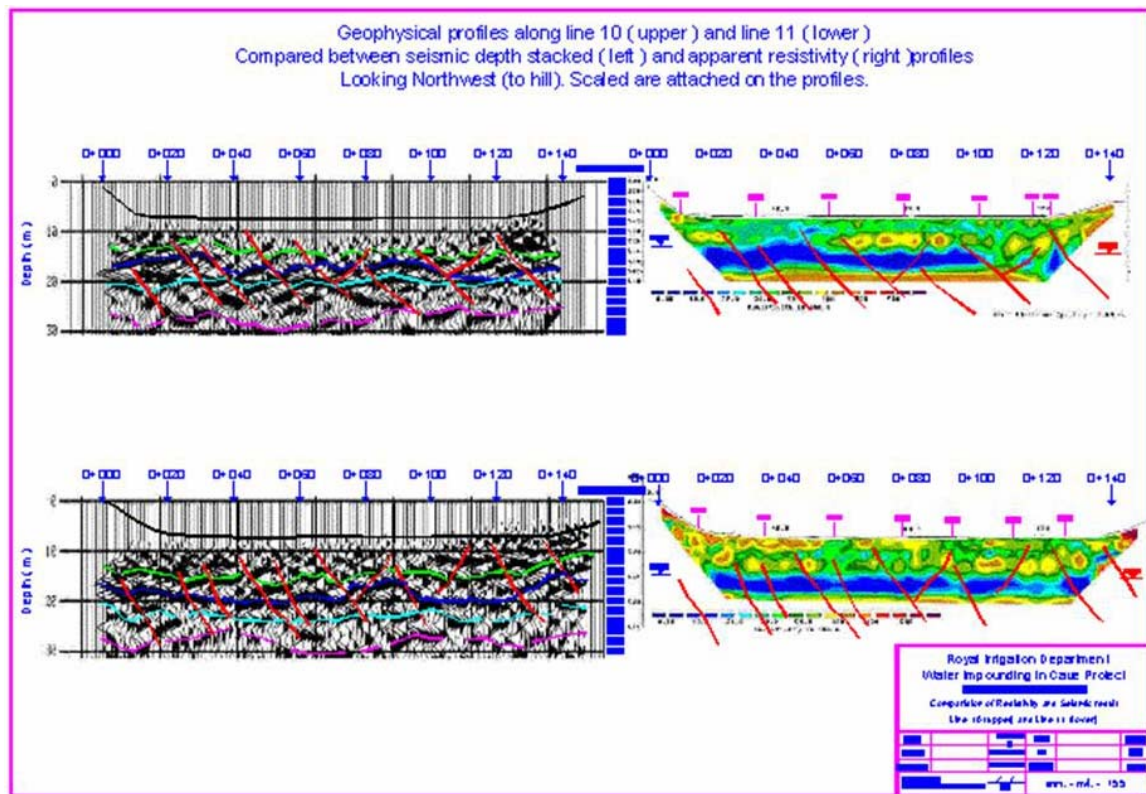
The reflection seismic profiling was only done over lines 10 and 11 because a minimum line length was required for surveying. The other lines were too short. An elastic wave was generated using a hammer sound source. Recording was with a McSeis 170f, OYO, Japan, 12-channel recording instrument. Group spacing was 2.5 meters and the configuration was split-spread. Depth penetration of this seismic wave was approximately 30 meters. The resultant seismic records were processed using SEISTRIX E software from INTERPEX Co., Ltd., U.S.A. The time domain wavelets of the stacked seismic sections were rather low resolution, though with rather broad peaks. This was because of the 40 hertz dominant frequency generated by the hammer sound source. The time stacked sections were converted to depth sections to make the seismic and resistivity results comparable for interpretation. On these seismic depth sections, four horizons are evident from the top of the compacted soil to the top of the weathered rock. Discontinuities occur within these four horizons and were interpreted as fractures, fracture zones, and a possible sink hole (Figure 4).

Figure 4. Comparison of geophysical results on lines 10 and 11

The results of the resistivity and seismic surveys have a close relationship. There are three different layers under the buffer pond. The topmost layer is a compacted clay blanket that receives various sizes of sediment during flooding in rainy seasons. The intermediate layer is a highly to completely weathered sedimentary rock. The third later, the basement, is moderately weathered sedimentary rock. The topmost layer is probably a pervious layer where water can flow along the trend of the brown to yellow shaded areas in Figure 5. The intermediate layer is probably an impervious layer of silt and shale and the basement is likely an impervious, high density layer. The fractures detected by seismic survey are probably the cause of leakage from the buffer pond, allowing water to move to the underlying basement. The two-dimensional dipole-dipole resistivity profiles were used to form fence diagrams, Figures 5 and 6. These diagrams show that the intermediate layer has good continuity and is, thus, an impervious layer. Water would flow on top of this layer. The gradient of the impervious layer was determined from the elevations of the top layer of the fence diagram profiles. The top of the intermediate layer is high in the west and low in the east, indicating that the intermediate layer slopes slightly to the east. The gradient of the top layer, the direction of seepage of the top layer, and the position and angle of dip of fractures indicate that water leaking from the top

layer flows from southwest to northeast and that it goes down to the basement in the overlapping area of lines 8 and 9 with lines 10 and 11.

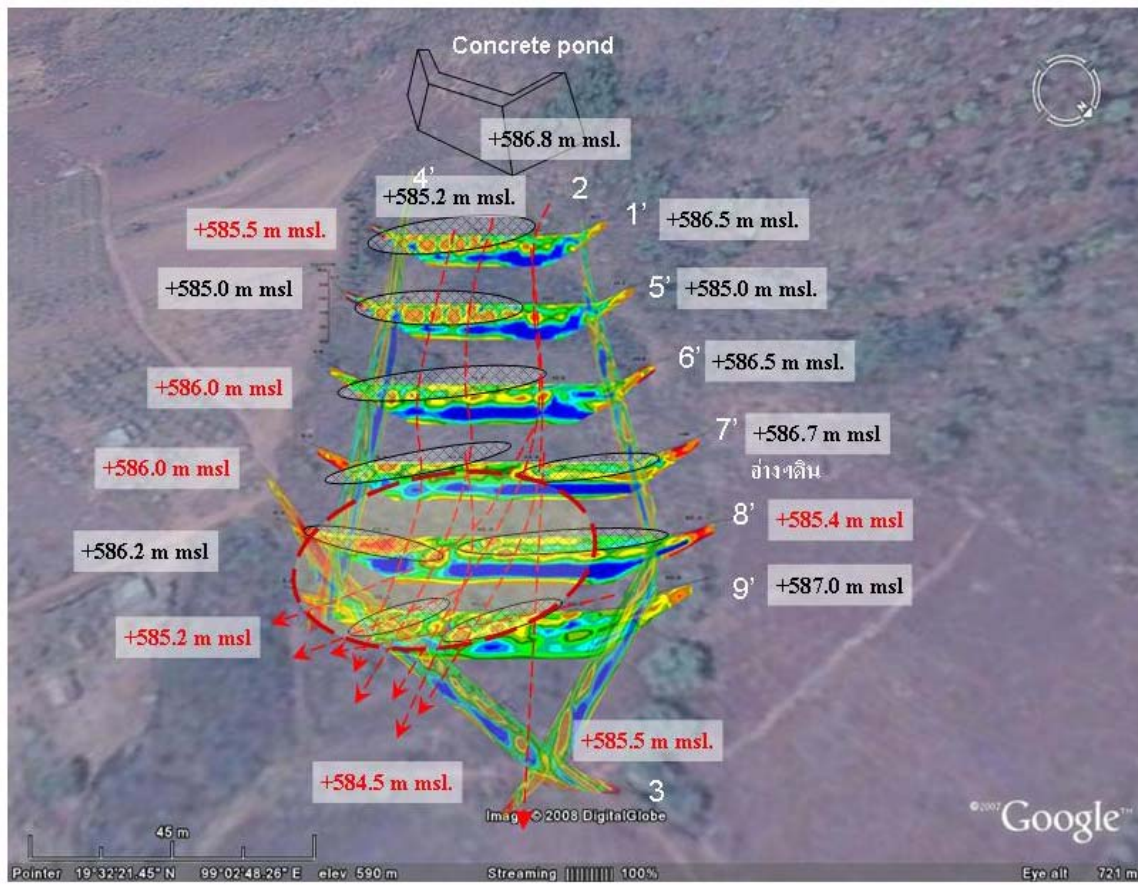
Figure 5. Fence diagram showing direction of flow along gentle slope

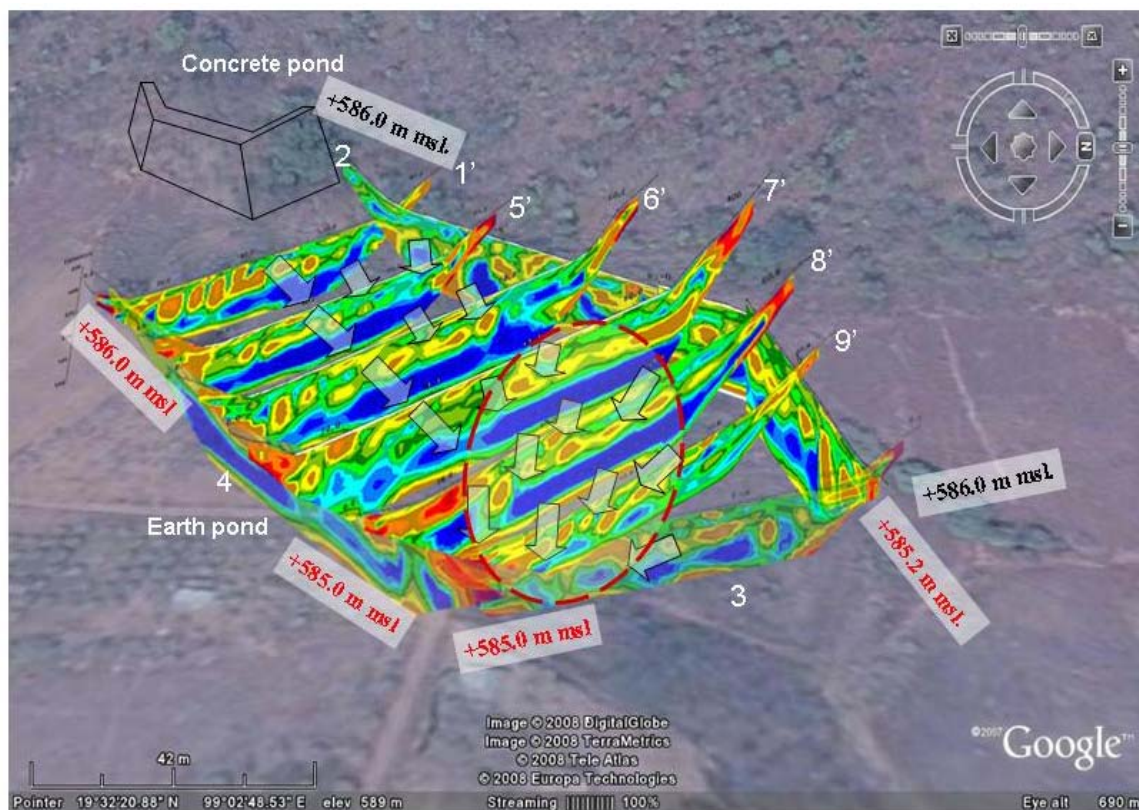
Figure 6 . Fence diagram showing an overlapping area where the water seeps downward

1. There are two main leakage paths in the study area:
 - (a) lateral leakage along the yellow to brown zone of irregular shape in the resistivity top layer (Figure 6) and
 - (b) vertical leakage along the fractures shown in stacked seismic sections (Figure 4)
2. The leakage pathway starts southwest of the earth pond, flows northeast in the top layer, and then goes down at the overlapping area of lines 8 and 9 with lines 10 and 11.
3. The combination of dipole-dipole and seismic reflection surveys was an effective method of determining water leakage and its pathway in the study area.
