Revealing Pathway of Leakage Under a Small Pond, Using Dipole-Dipole Resistivity and Shallow Seismic Reflection; A Case History at Tum Huai Luk Project, Chiang Mai, Thailand.

N. Poomvises, N. Sangthong and A. Kongsuk

Geophysics group, Geology Section, Office of Topographical and Geotechnical Survey, Royal Irrigation Department, Bangkok, Thailand

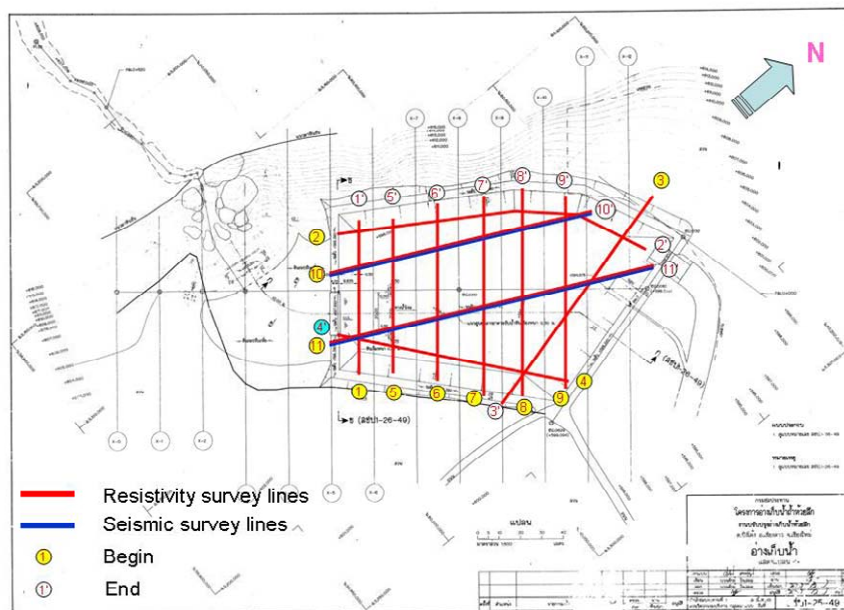
Figure 2. Geophysical survey lines

The resistivity investigation consisted of 11 profile lines (Figure 2). This survey used a SYSCAL R1 switch, a French IRIS instrument, 24 nodes, 2.5-meter electrode spacing, and had a 20-meter penetration depth. Survey lines 1, 2, 3, and 4 were designed to check the lower edge of the pond on the floor level. Lines 1, 5, 6, 7, 8, and 9 were perpendicular to the axis of the buffer pond. Lines 10 and 11 were parallel to the pond's axis. The resistivity raw data were good and were modeled using RES2DINV processing software of M.H. Loake, GEOELECTRIC, Malaysia. Modeling results showed three different layers on most of the processed lines (Figure 3).
